RISK ASSESSMENT OF DOUBLE-SKIN BULK CARRIERS

K.J. Spyrou, A.D. Papanikolaou, M. Samouelidis, D. Servis and S. Papadogianni, Department of Naval Architecture and Marine Engineering. National Technical University of Athens, Greece

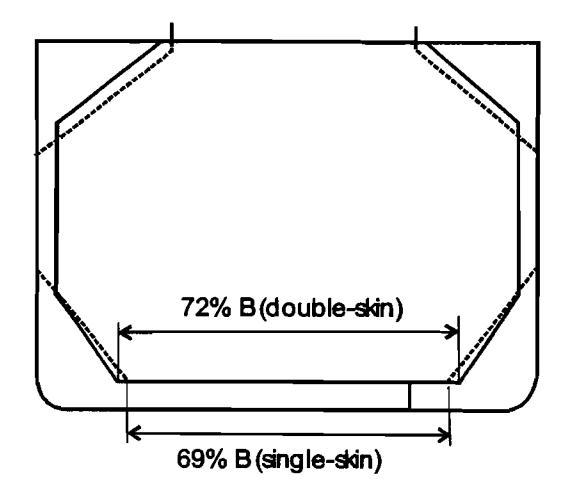
Fig. 2: Comparison of the layout of a typical cargo hold of a Panamax for DS and SS construction.

In Fig. 1 is shown a DS bulk-carrier at the construction phase from Oshima, the Japanese shipyard which has pioneered the construction of such vessels [4]. Instead of modifying the principal hull dimensions in order to compensate for the reduced cargo hold space, they have used smaller topside and hopper tanks, Fig. 2.

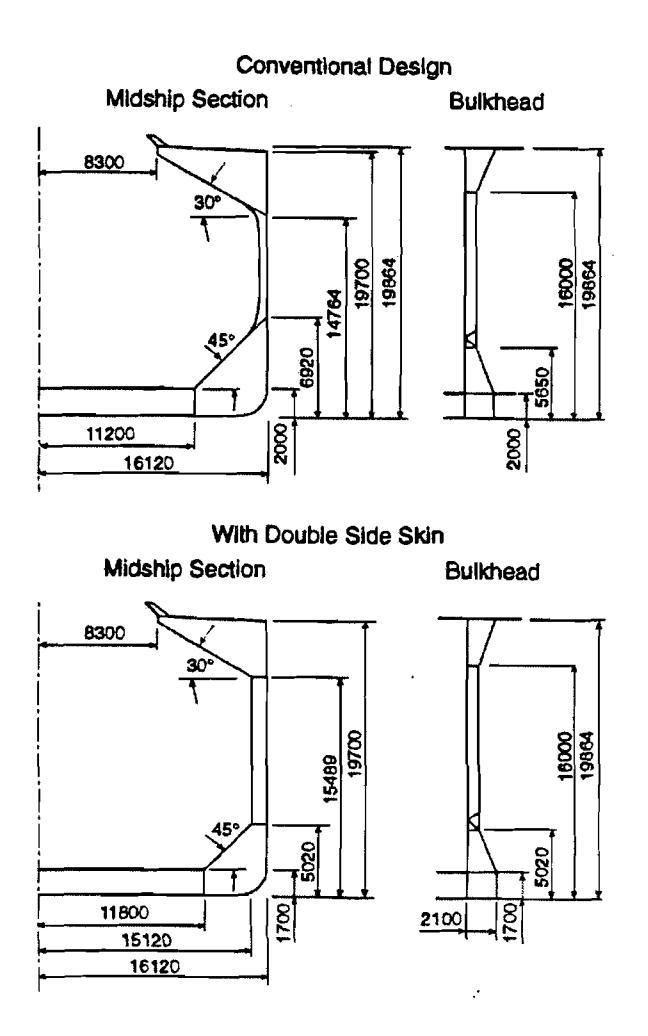
Double Side Skin Hopper Plating locally + 2 + 6,5 mm Bottom Shell + 3 + 6,5 mm Bottom Girders locally + 5 + 12,5 mm

Fig. 4: Typical required structural reinforcements for a double-skin bulk-carrier [5].

The double-hull design was derived from a 225.0 m long single-skin vessel. The cargo space was comprised of seven holds. Six of these had the same length while the tanks for the consumables were placed around the engine room. A finite element study was carried out for the vessel with the double skin and an important finding was that the thickness of the inner bottom in the empty holds (2, 4 and 6) should be increased due to the reduced height of the double bottom. The higher double bottom influences also the thickness of the bottom girders and the inclined plating of the hopper tank. The reinforcements that needed to be introduced are summarised in Fig. 4.

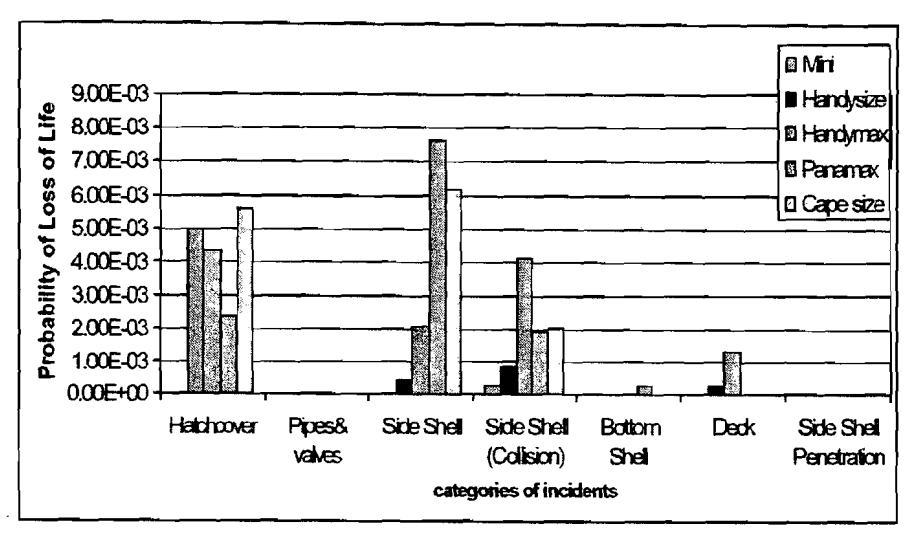
Fig. 5: Probability of Loss of Life per BC Classes [7]

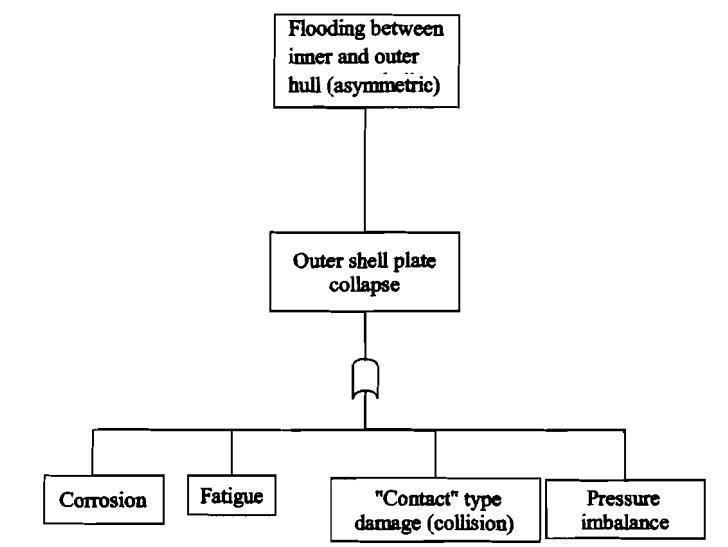
Fig 6: Asymmetric flooding

This involves either the occurrence of asymmetric flooding through the outer hull, with no penetration of the inner hull, or the occurrence of flooding due to "deep" penetration extending inwards of the inner shell structure. Reg. 4 of Chapter XII of SOLAS must be rephrased, to account for the above two cases which are not applicable to bulk-carriers of single-skin construction. We have carried out a detailed study on these issues, reported in Section 7.

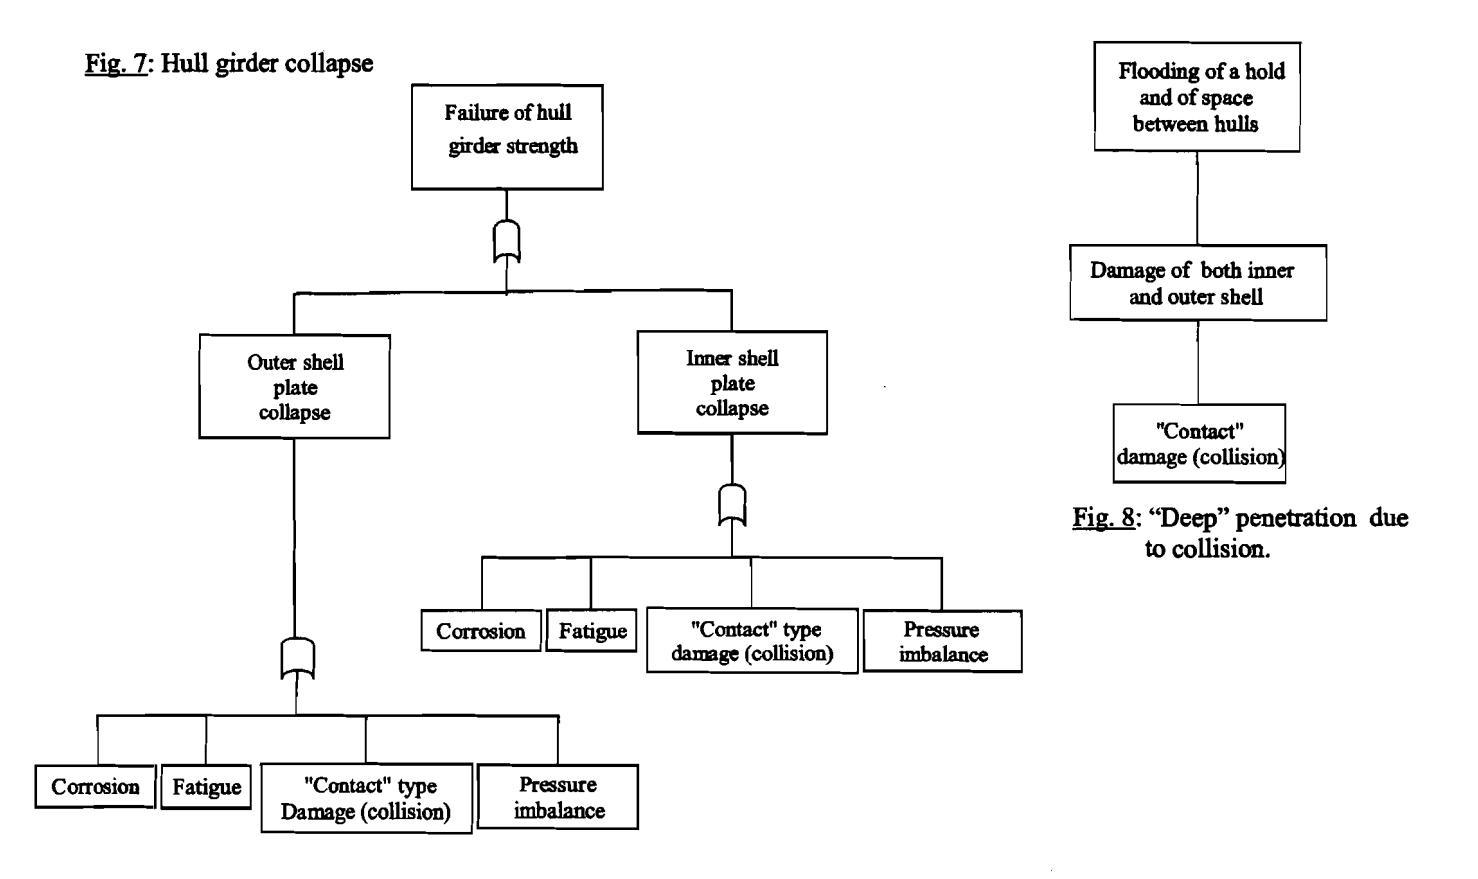
Below are shown qualitative fault trees for the three main scenarios, i.e. a) flooding of the space between the two hulls, b) flooding of a hold as well as of the space between the hulls, and c) failure of hull girder strength, are presented in Figs 6 to 8 (scenarios of side-shell structure collapse are only examined).

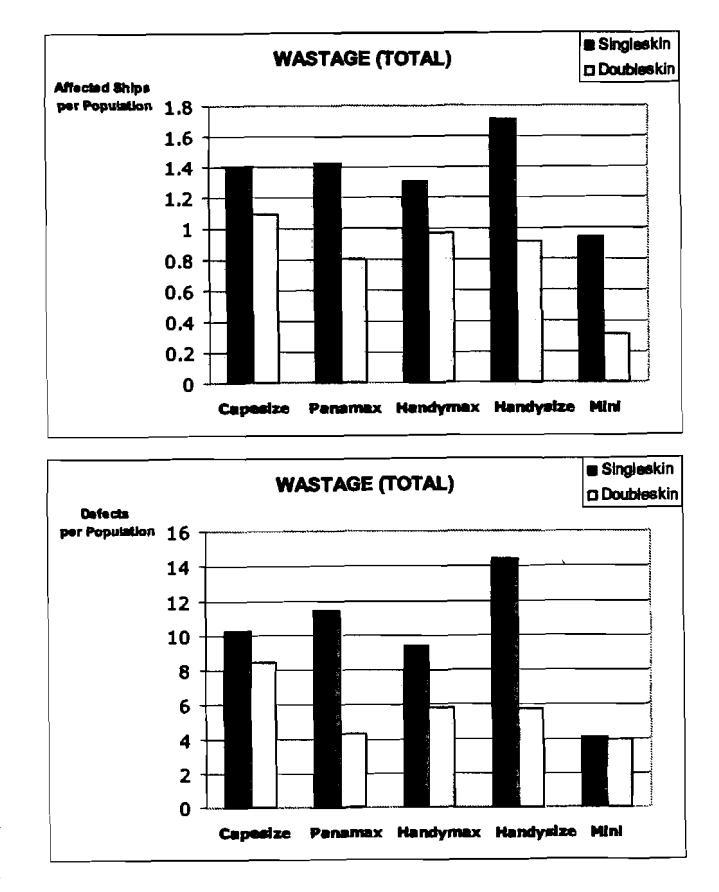
Fig. 9: Wastage incidents and defects

In terms of wastage, the SS group seems to be more vulnerable (except for the Capesizes were the picture is more balanced, with the number of DS incidents/defects even slightly exceeding that of SS), this however is likely to be reflecting the younger age of the DS fleet. In terms of the "non-contact" cases, the trend appears reversed and (with the exception of capsize vessels again) the DS vessels appear to have more problems.

The wastage is consistently higher in the DS group for all sizes. Again the trend is reversed for the non-contacts, with the exception of Capesize vessels.

The records on wastage are excessive for the SS in the larger sizes (Panamax and Capesize) while the records are more balanced in the smaller categories. In terms of non-contacts, the DS appear more vulnerable in all sizes.

More defects due to wastage are recorded for the DS. Wastage incidents appear excessive for the DS in the Handymax and Panamax categories. In terms of noncontacts, the DS Handymax type appears very vulnerable.

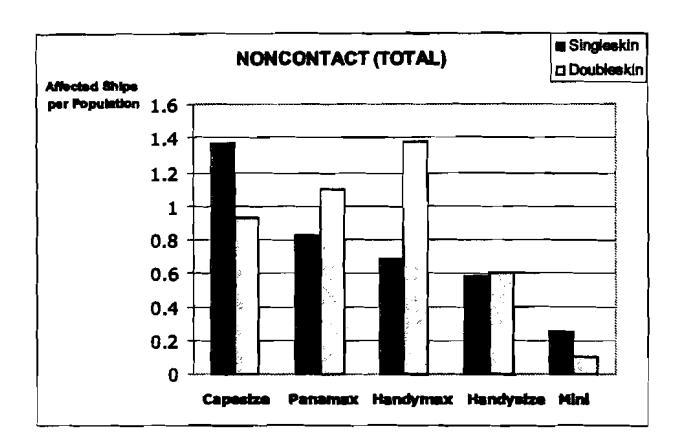
Fig. 10: Non-contact incidents and defects

In terms of wastage, the SS presents excessive incidents and defects (once more, however, it must be stressed that this result is probably biased due to the probable higher average age of the SS group). On the other hand, the DS presents more incidents and defects of the "non-contact" type, especially in the category of Handymax.

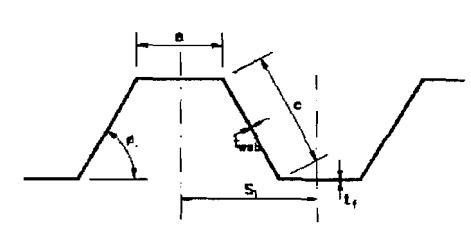
Fig. 11: Bulkhead configuration

The dimensions of the first hold are shown in Table 6. The dimensions of the corrugated bulkhead between holds No.1 and 2 for both vessels are given in Table 7 and Fig. 11. The alternate loading condition was applied for both vessels. The pressure head was calculated according to the vessel's plans (Table 8 and Fig. 12). Finally, the bending capacity of the corrugated transverse bulkhead is shown in Table 9.

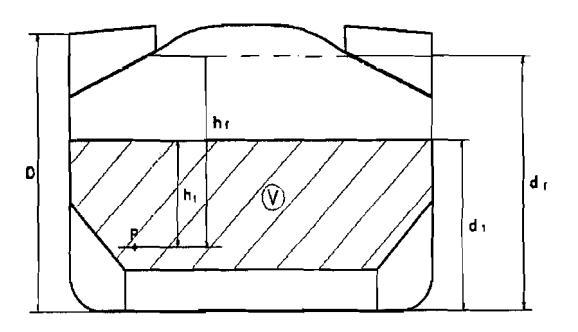
Fig. 12: Definitions for calculation of pressure head
